INITIAL EMERGENCY RESPONSE ACTIONS FOR THE KINGSTON FOSSIL PLANT ASH DIKE FAILURE

Roane County, Tennessee

PREPARED BY:
TENNESSEE VALLEY AUTHORITY

FEBRUARY 2009

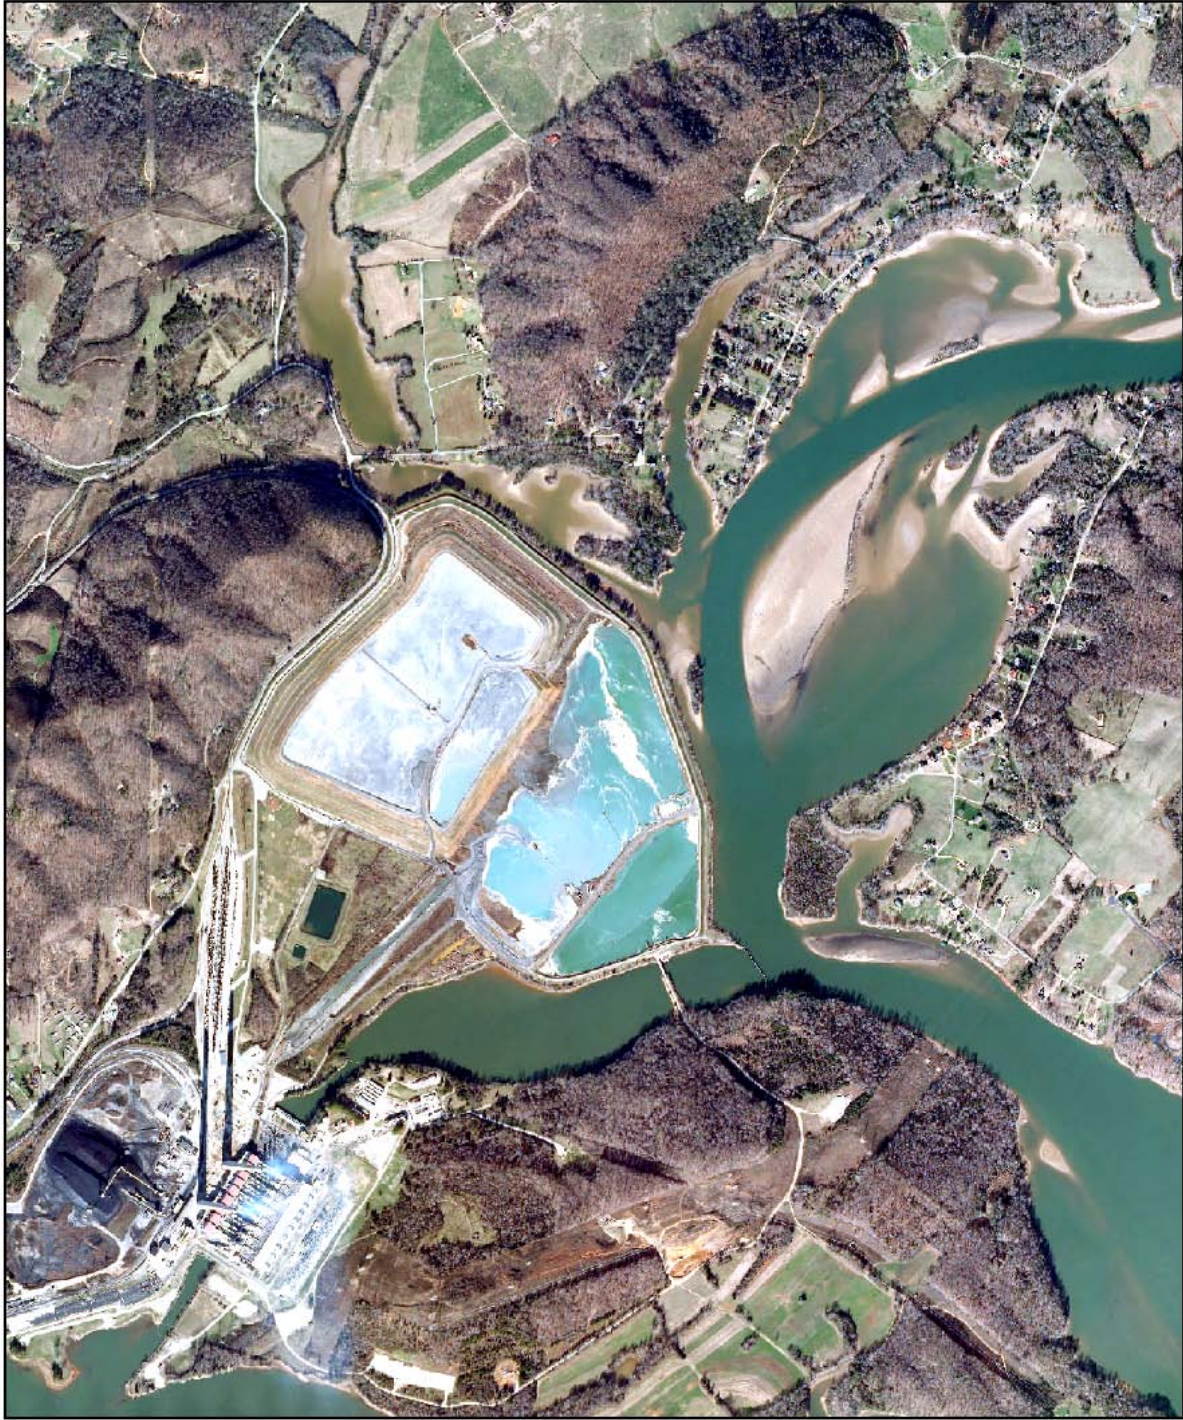
Figure 1. Kingston Fossil Plant Area Pre-Dike Failure

On Monday, December 22, 2008, a dike containing the KIF dredge cells collapsed, releasing about 5.4 million cubic yards of fly ash and bottom ash. Ash was released from about 60 acres of the 84-acre dredge cell complex. The spilled material now covers about 300 acres of adjacent parts of Watts Bar Reservoir, including most of Swan Pond Creek embayment, and reservoir shorelands. Figure 1 illustrates the area prior to the dike failure,

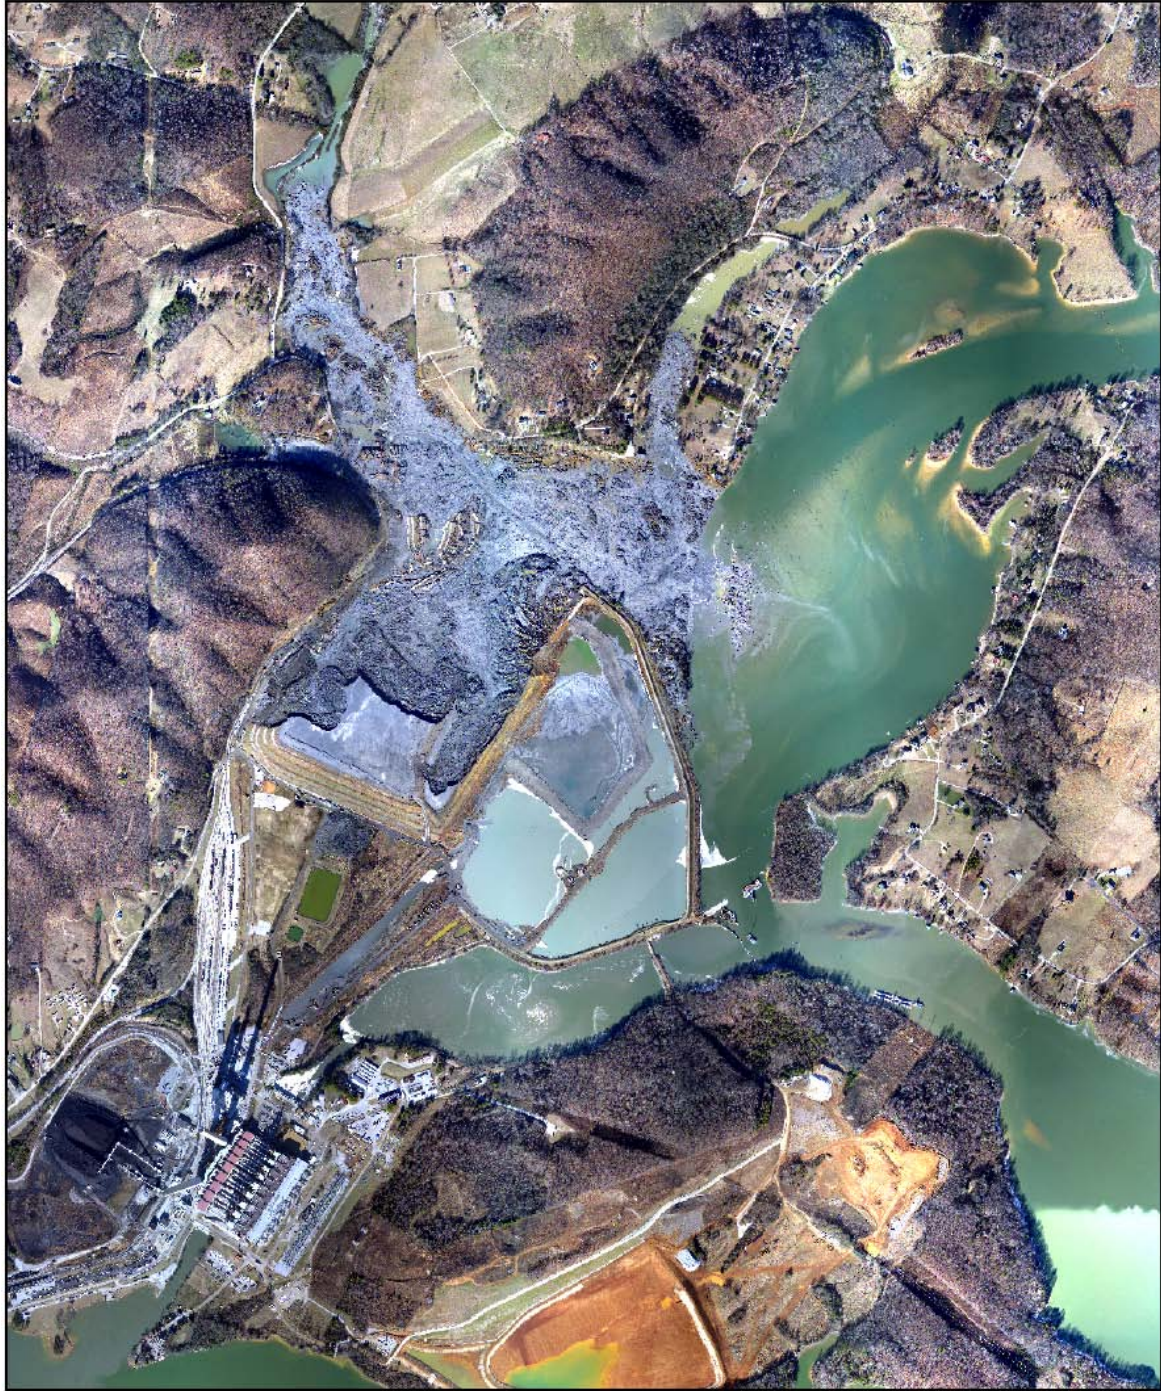
Figure 2. Kingston Fossil Plant Area Post-Dike Failure

and Figure 2 shows the area on December 30, 2008, after the dike failure. No injuries occurred, but several residences were affected. Three houses were severely damaged and are now uninhabitable. Portions of the rail line serving KIF, Swan Pond Road, and Swan Pond Circle were covered with ash, and water, electrical, and gas services to the adjacent area were interrupted.

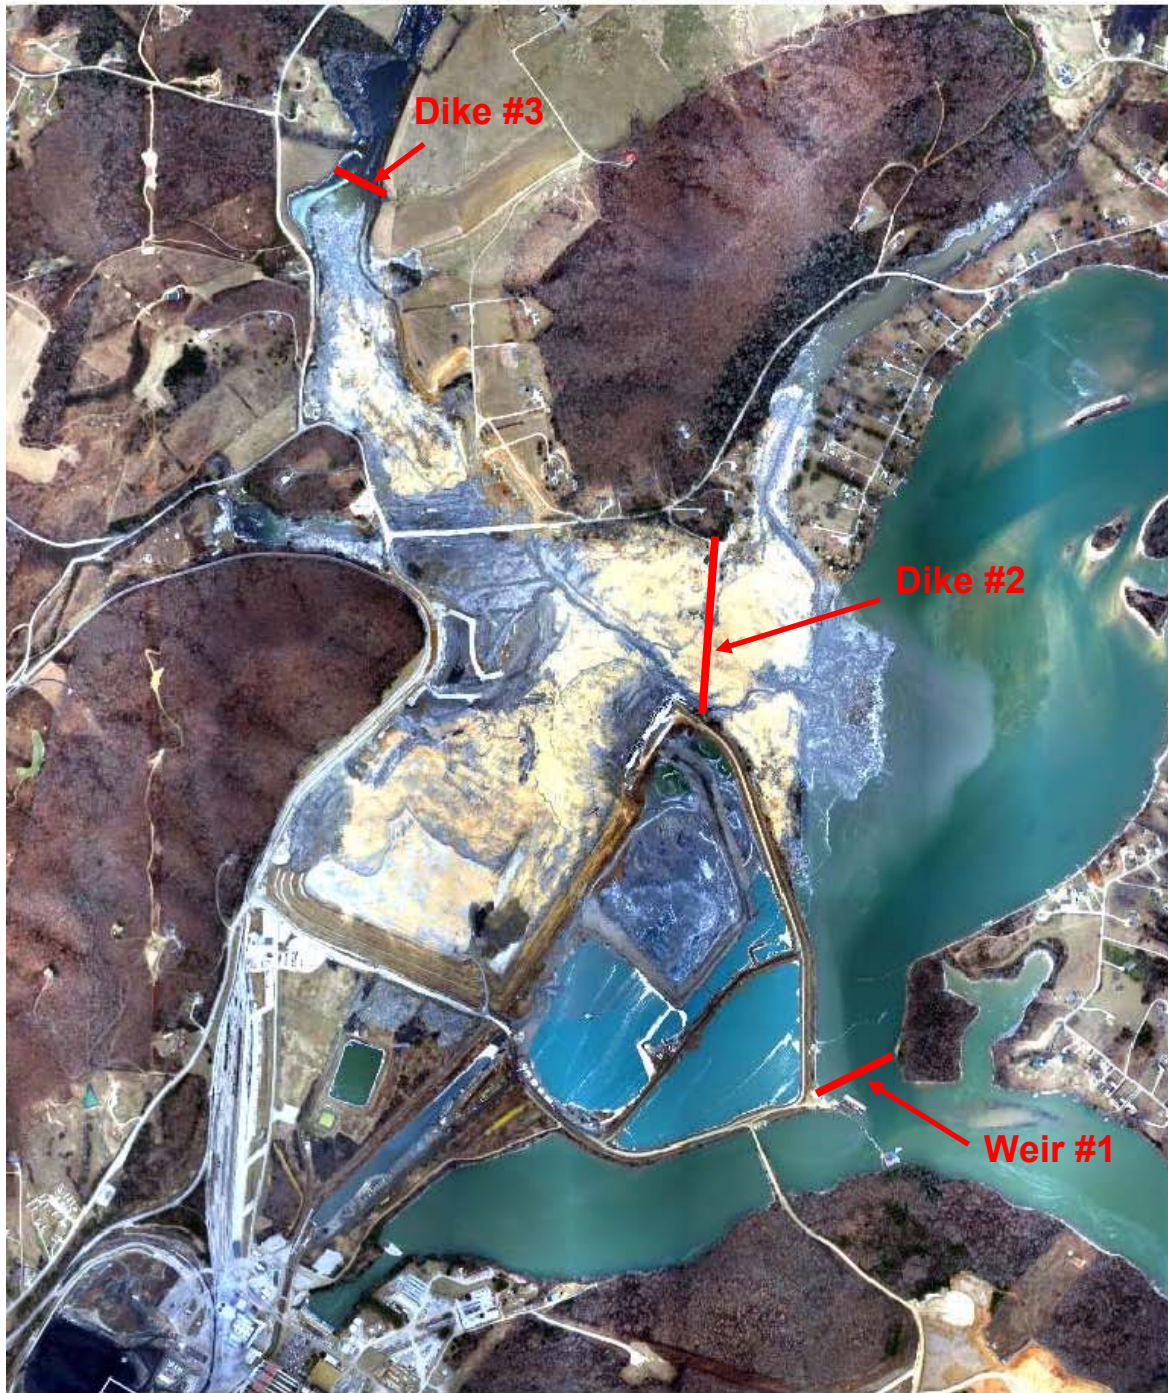
Figure 3. Weir and Dike Locations

The spilled ash has filled most of the Swan Pond Creek embayment to the north of the former ash pond area and an adjacent stretch of the Emory River. The Emory River was closed for the first 30 days to all boats not associated with the emergency response and restoration effort between Mile Marker 0 and Mile Marker 4, and the area was patrolled by U.S. Coast Guard (USCG) and TVA Police marine units. To prevent the downstream migration of fly ash and dike material, TVA is constructing three temporary rock structures (Figure 3).

The first rock structure, Weir #1, completed on January 5, 2009, is built across the Emory River, just north of the existing intake skimmer weir. The weir is about 630 feet long, and the top of the weir is approximately at elevation 731.8. There is a 50-foot notch in the weir at about elevation 727.3.

The second rock structure, Dike #2, would extend across the Swan Pond Creek embayment a short distance upstream of its mouth. Based on preliminary plans, the dike would be about 1,750 feet long. The top elevation of most of the dike would be 752.0 feet; a 300-foot-wide spillway section would have a top elevation of 745.0 feet. When complete, this dike will minimize the movement of ash from the embayment into the Emory River.

The third rock structure, Dike #3, would be constructed across the Swan Pond Creek embayment about 0.5 mile upstream of its mouth and just upstream of the spilled ash (Figure 3).

Temporary Weir #1 is located at about Emory River Mile (ERM) 1.9. For this reach of the Emory River, the USACE obtained underwater cross sectional data in 2007, prior to the dike breach. In addition, the USACE obtained underwater cross sectional data shortly after the breach to document the extent of the ash in the Emory River. TVA staff obtained these data from the USACE and input this information into HEC-RAS models of the Emory River to determine estimated potential upstream flood impacts resulting from construction of Weir #1 and the ash in the river. The 100-year flood post-spill elevations would be about 5 feet higher than prespill elevations immediately upstream of Weir #1 and about 8 feet higher than prespill elevations in the vicinity of the houses located along Emory River Road and Lakeshore Drive. The 100-year flood post-spill elevations would affect land and structures that TVA currently does not own. Until the ash and the weir are removed, there is an increased risk of flooding for some river-front properties in the event of a 100-year flood. TVA has performed post-spill flood-risk evaluations and determined that the 100-year flood post-spill elevations would be higher than prespill elevations all the way through Harriman, which is about 11 miles upstream. About 100 structures may be in the 100-year post-spill floodplain that were not previously within the 100-year floodplain. TVA will be performing individual home floor elevation surveys so TVA has the specific information needed in the unlikely event of a flood. TVA will be financially responsible for flood damages to homes that would not have occurred under normal conditions, in the absence of the ash in the river and the temporary weir. TVA is proposing to dredge the ash from the Emory River, remove Weir #1, and return the streambed of the Emory River to prespill conditions. Once this is completed, the Emory River flood elevations would be the same as those shown on the updated Roane County Flood Insurance Rate Maps. Because the increases in the flood elevations resulting from Weir #1 and the ash in the Emory River would be temporary, the long-term impacts on flood elevations would not be significant.

Temporary Dike #2 would be constructed at about Swan Pond Creek Mile 0.2. The purpose of Dike #2 is to prevent the ash from areas upstream of this weir (including the embayments) from flowing into the main Emory River channel. Dike #2 is not expected to affect flood elevations on the Emory River. TVA staff has made preliminary calculations on the volume of water that would pass over Dike #2 during normal flow and flood conditions and will continue to provide information as needed.

Temporary Dike #3 would be constructed at about Mile 0.5 on the small tributary that feeds the Swan Pond Creek embayment to prevent the water from entering the area that is currently full of ash. TVA would ensure the flood elevation resulting from the installation of this weir would not adversely affect structures with the collection of appropriate hydrologic and hydraulic data.

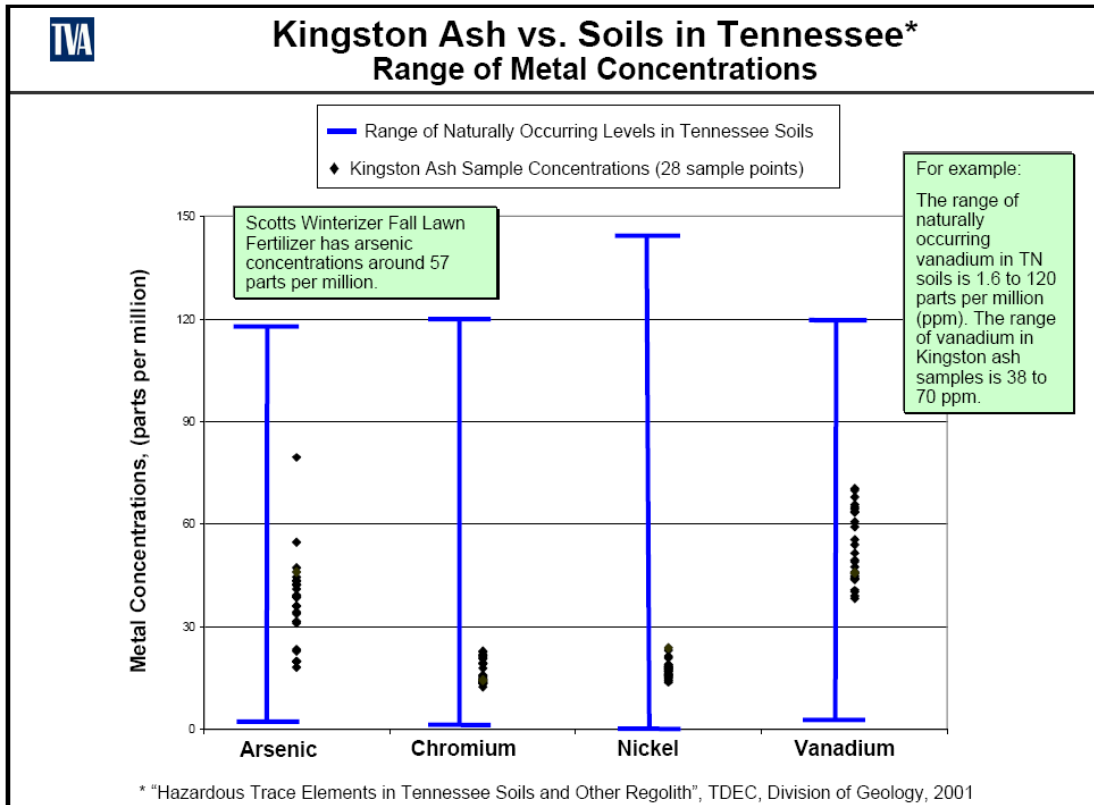
Table 1. Kingston Ash vs. Soils in Tennessee for Arsenic, Chromium, Nickel, and Vanadium

Fly ash is composed primarily of aluminosilicate glass with smaller percentages of iron, calcium, magnesium, sulfur, sodium, and potassium in their oxide forms as depicted in Table 3. In addition to the major components, fly ash also contains heavy metals concentrations in part per million and part per billion concentrations. These metals are bound in an amorphous glass structure of the fly ash particles and are considered insoluble except in strong acidic or basic solutions. The metals are not typically considered as being available to the food web without ingestion of the fly ash. As fly ash weathers because of its size and composition, it weathers to noncrystalline clay, and with the addition of water, this would form various hydrous aluminosilicates that are essentially the composition of all clays. Clays have a high cation exchange capacity and the ability to attenuate metals that may become soluble during the weathering process binding them in fashion that is not bio-available unless ingested.
