Report of Phase 1 Facility
Assessment

Coal Combustion Product
Impoundments and Disposal
Facilities

Various Locations, Kentucky

June 24, 2009

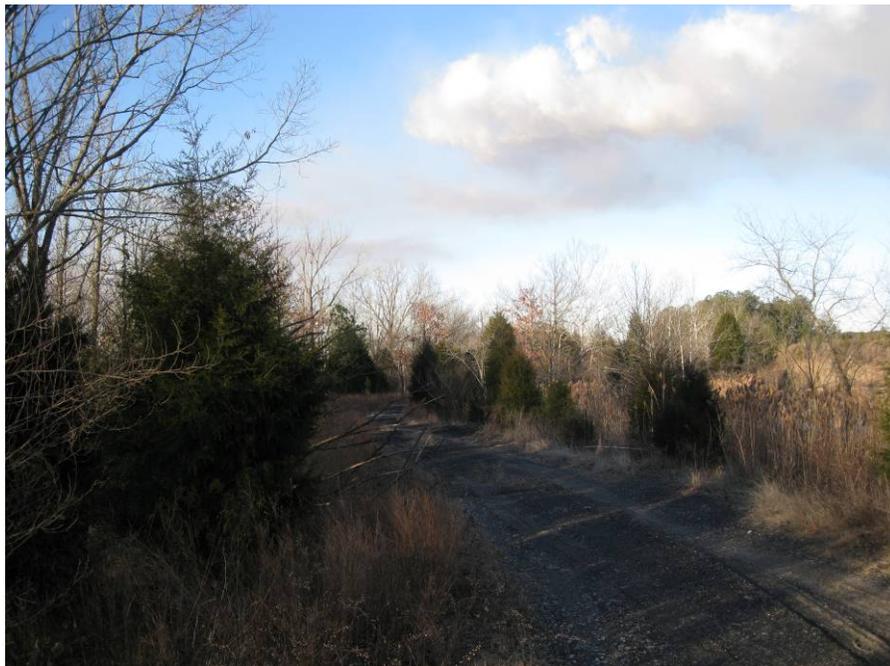
Drawing Mark SM P1-4 Dense vegetation including large trees on both interior and exterior slopes.

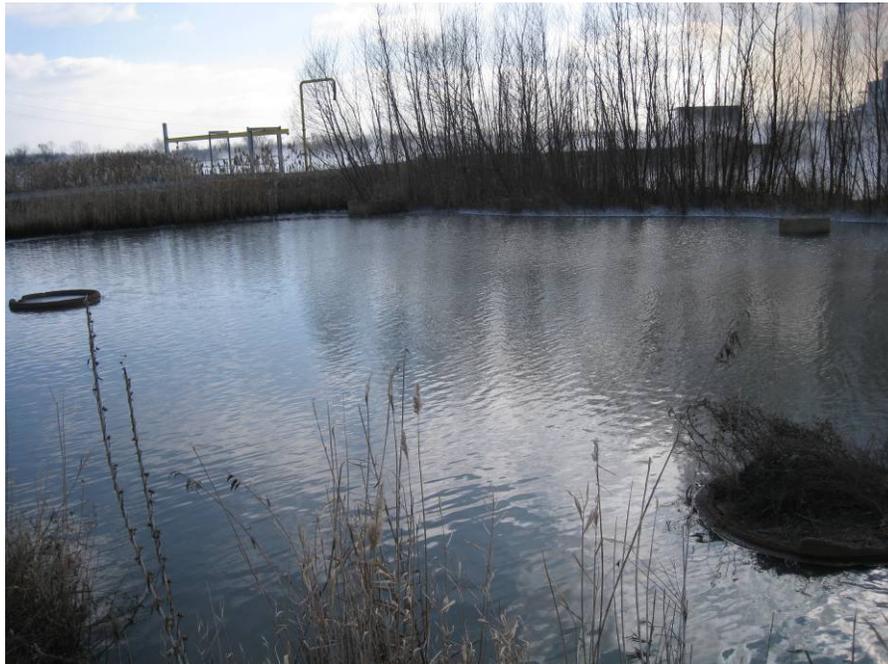
Drawing Mark SP 2A-4 Four riser pipe spillways on north end of Pond 2A.

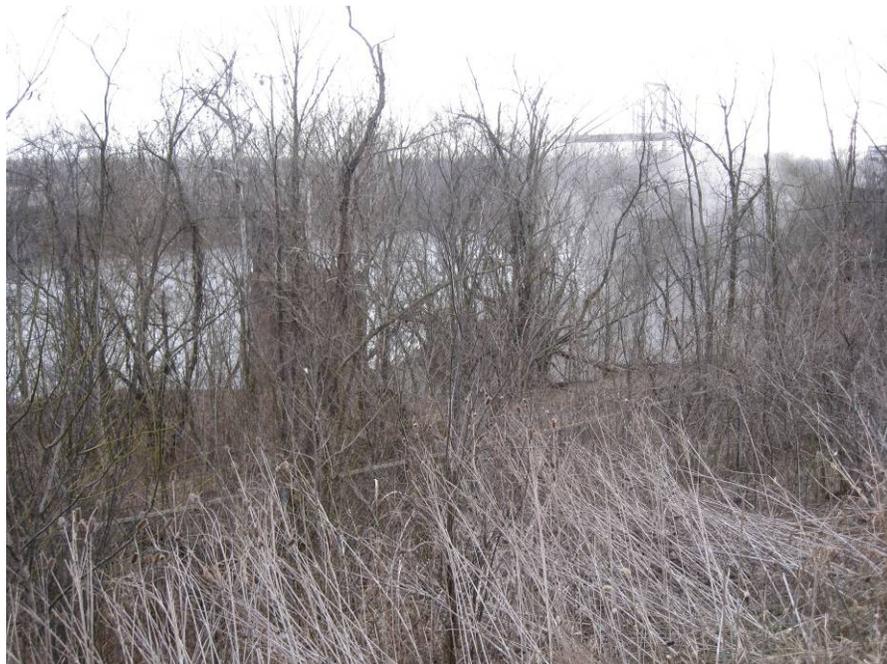
Drawing Mark SP 2B-2 Trees and other vegetation along north east slope to Green River.

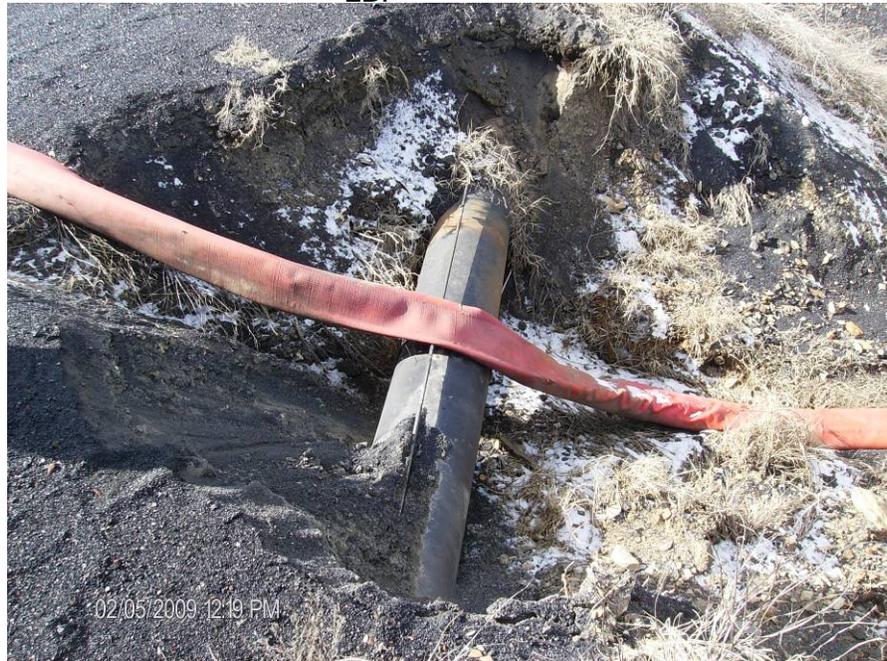
Drawing Mark SP 2B-7 Erosion gully exposing buried pipe line.

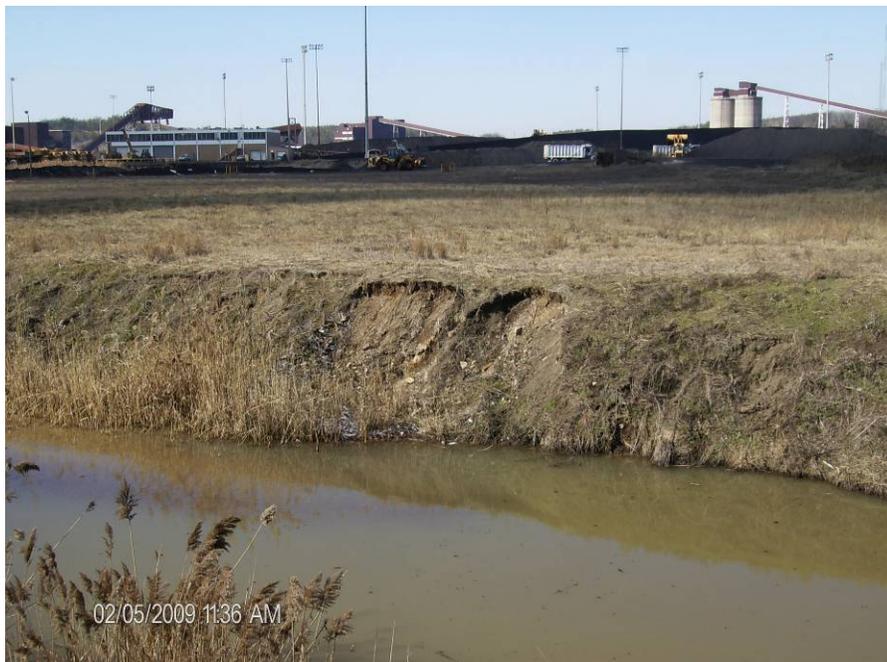
Drawing Mark SSP-2 Slumping along southwest interior slope of the Slag Stilling Pond.
